TRANSPORTATION RESEARCH CENTER

**ON-SITE SCHOOL BUS INVESTIGATION**

CASE NO. - 95-22  
FLEET - CORPORATE SCHOOL BUS  
LOCATION -  
ACCIDENT DATE - 1995

Contract Number: DTNH22-94-D-17058

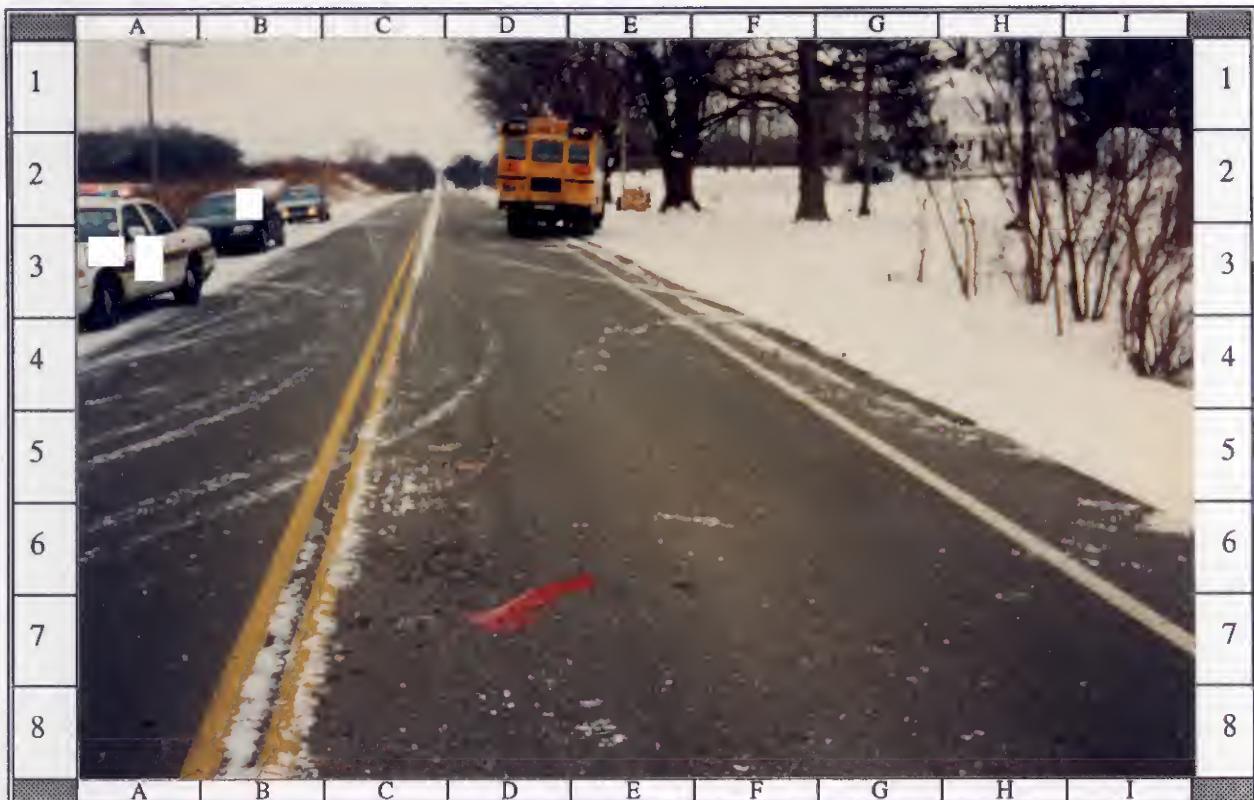
# 01: On-scene view in westbound lane of residual impact evidence of child who had just exited bus; NOTE: possible brain tissue on pavement (cells C5--D5)

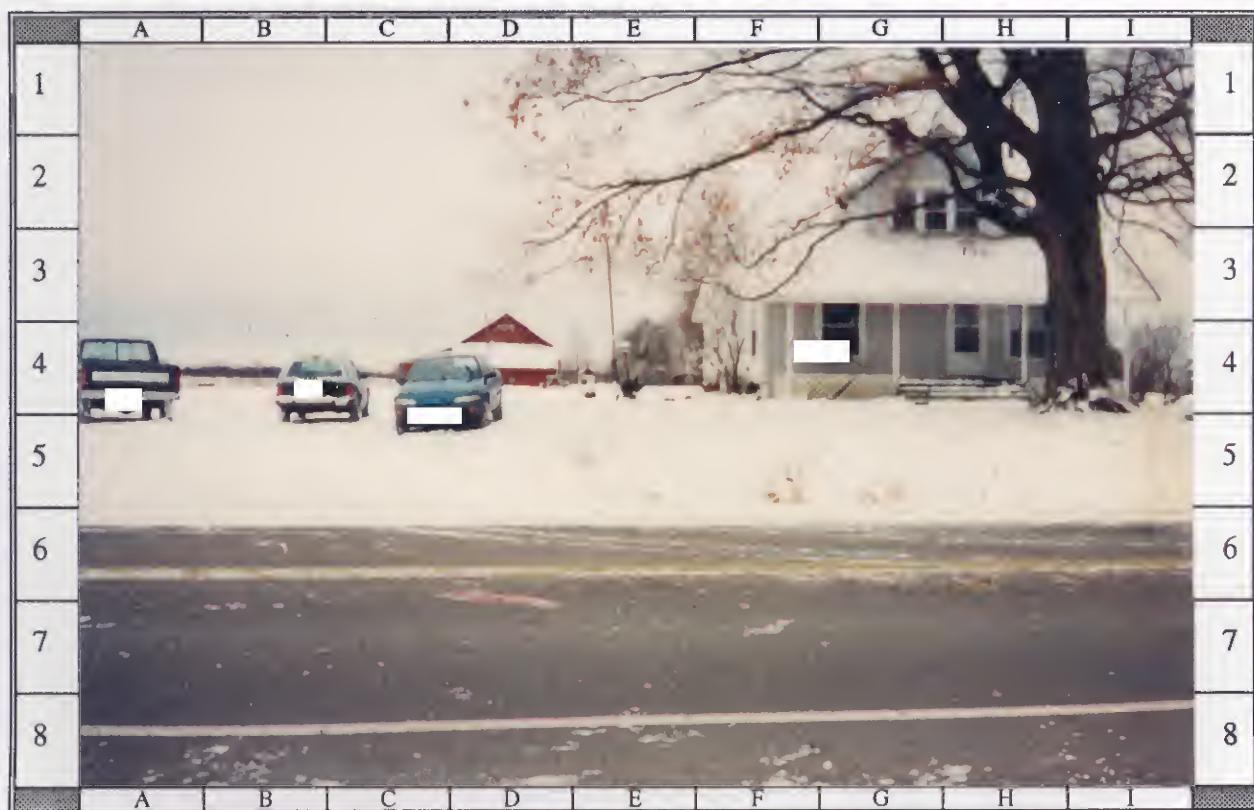
# 02: On-scene southward view in westbound lane of residual impact evidence of child who had just exited bus; NOTE: child heading toward driveway in background

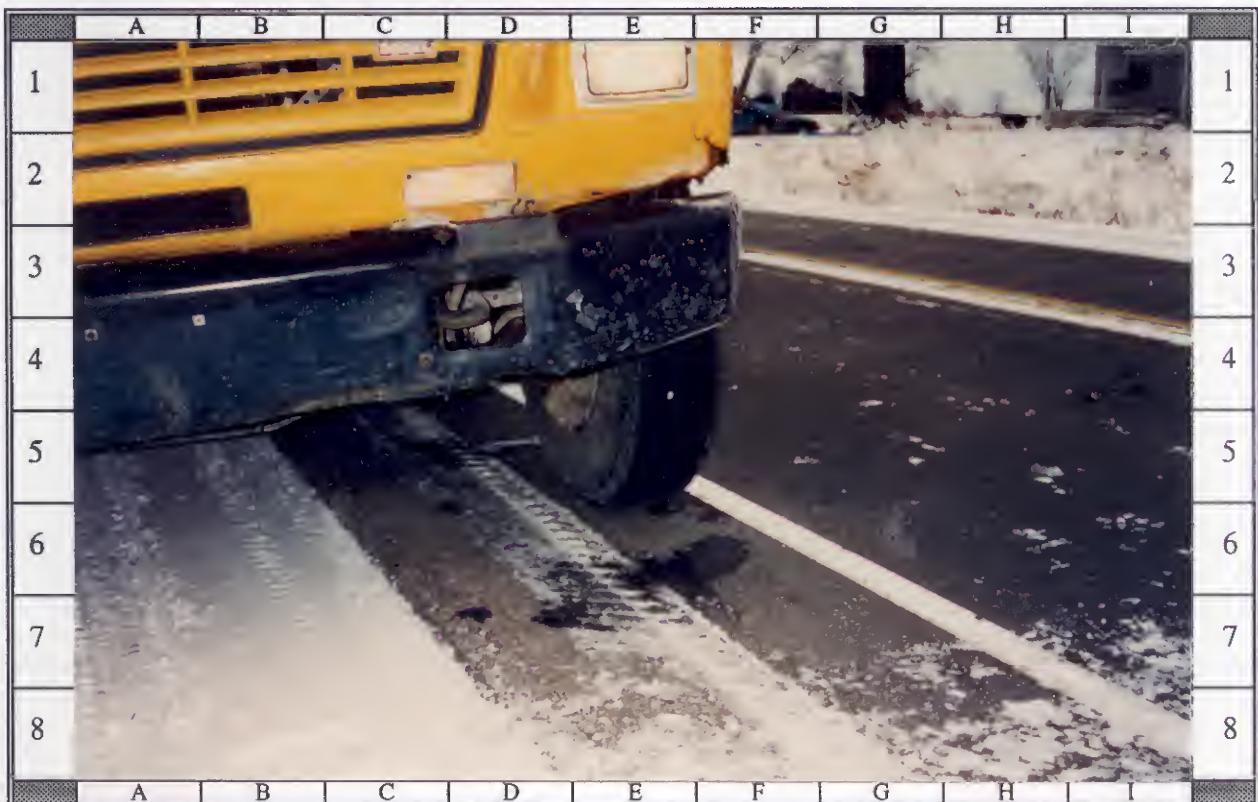
# 03: On-scene view of Case Vehicle's front left bumper and left front tire, which knocked child down and passed over her, respectively

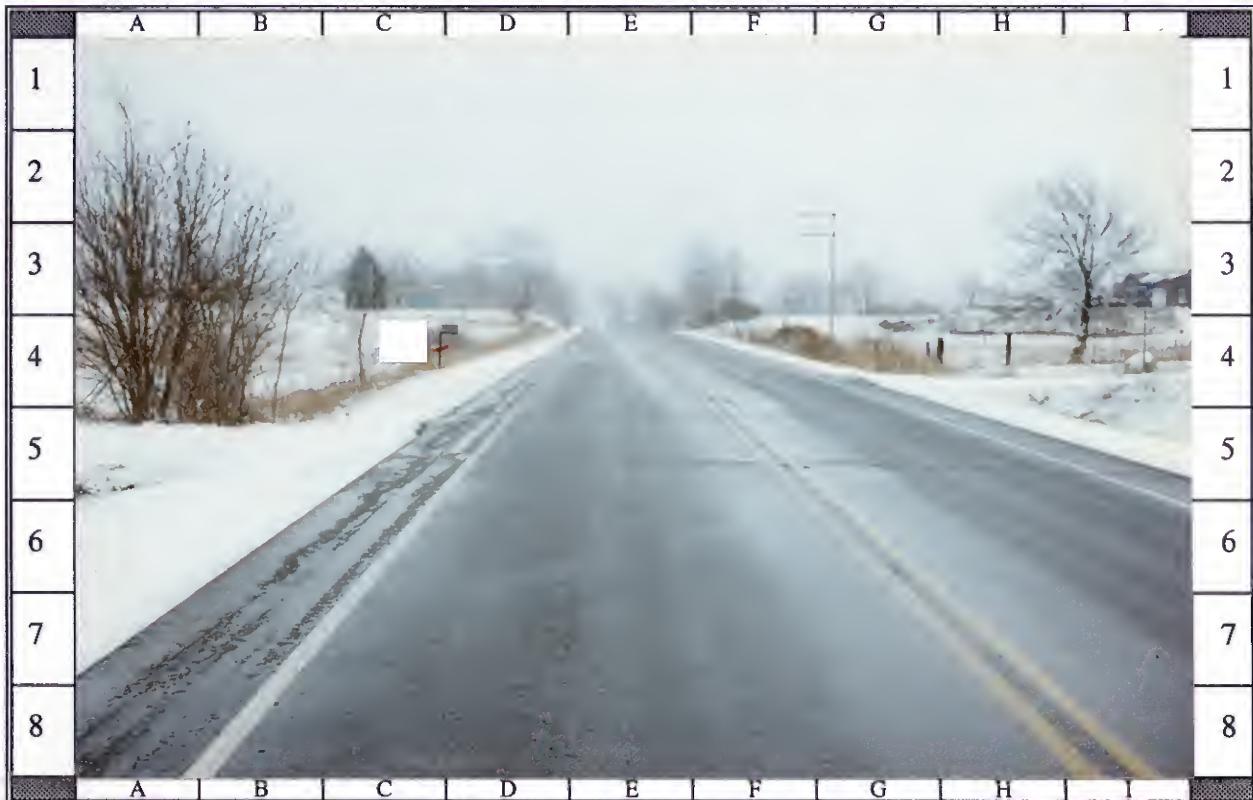
# 05: Eastward view of approximate impact location of westbound Case Vehicle and child who had just exited bus; NOTE: impact near mailbox (cell E4)

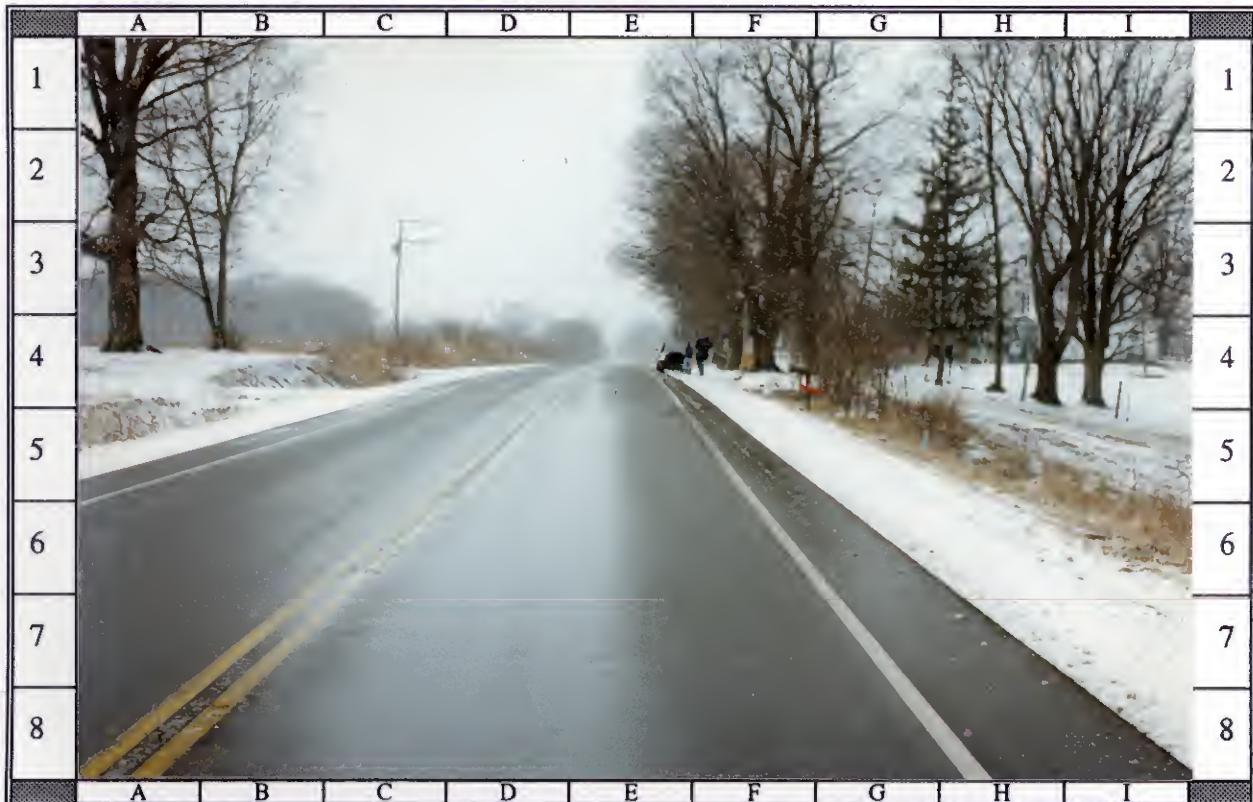
# 06: Case Vehicle's westward travel path in westbound lane approximately 50 meters (164 feet) east of impact near mail box (cell E4)

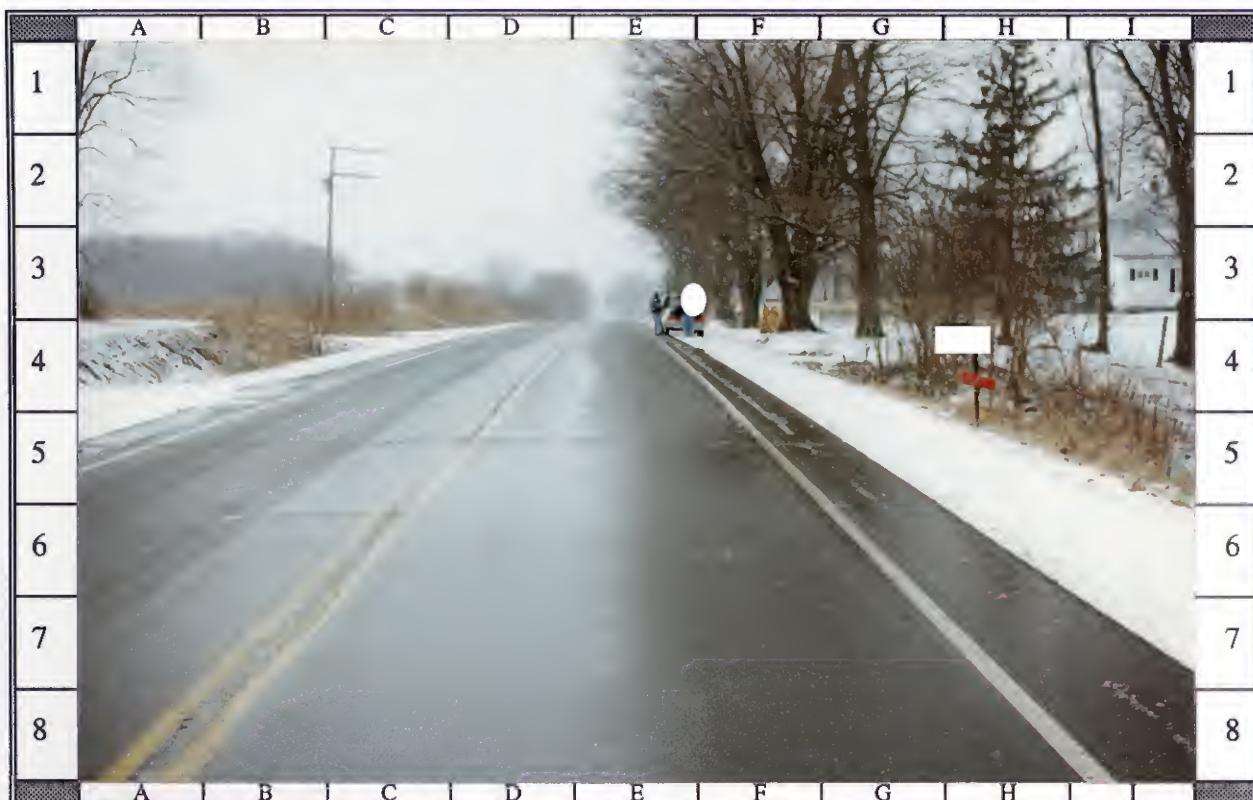
# 07: Case Vehicle's westward travel path in westbound lane approximately 25 meters (82 feet) east of impact near mail box (cell D4)

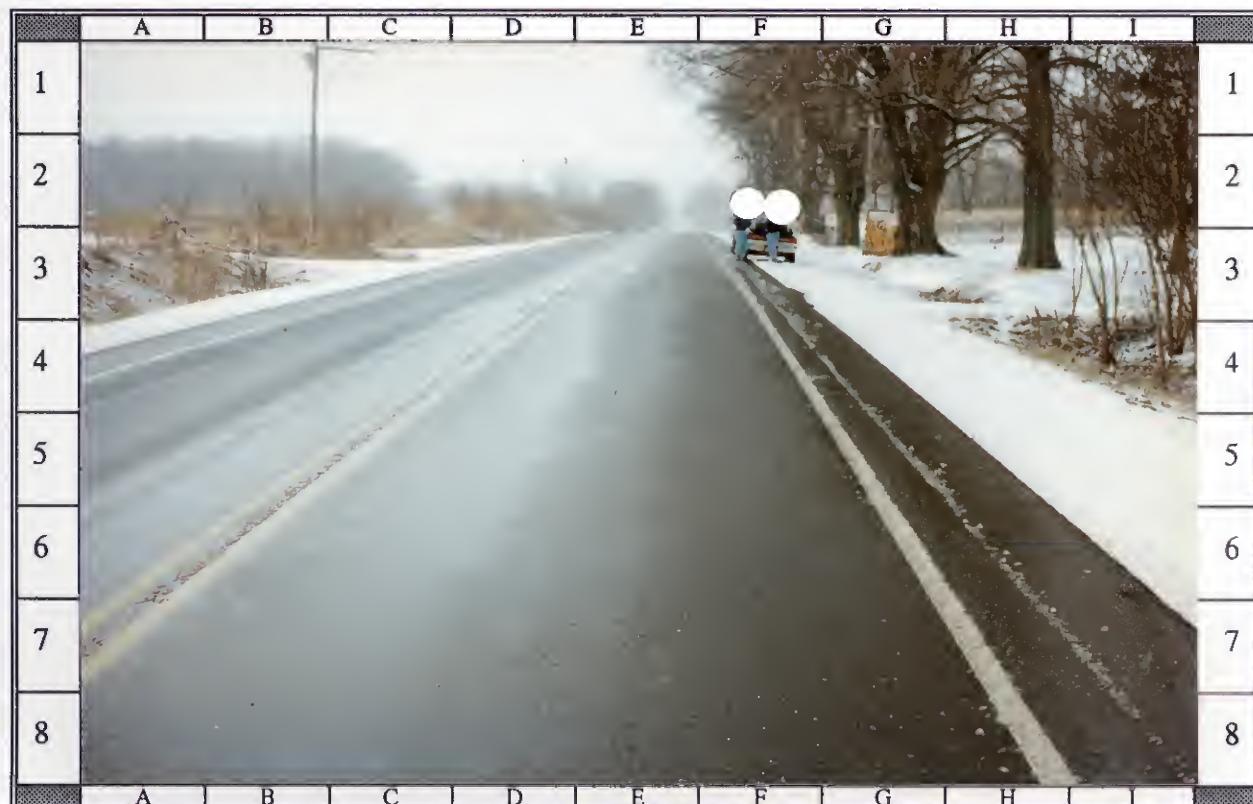
# 08: Case Vehicle's westward travel path in westbound lane approximately 5 meters (16 feet) east of impact near mail box (cell D5)

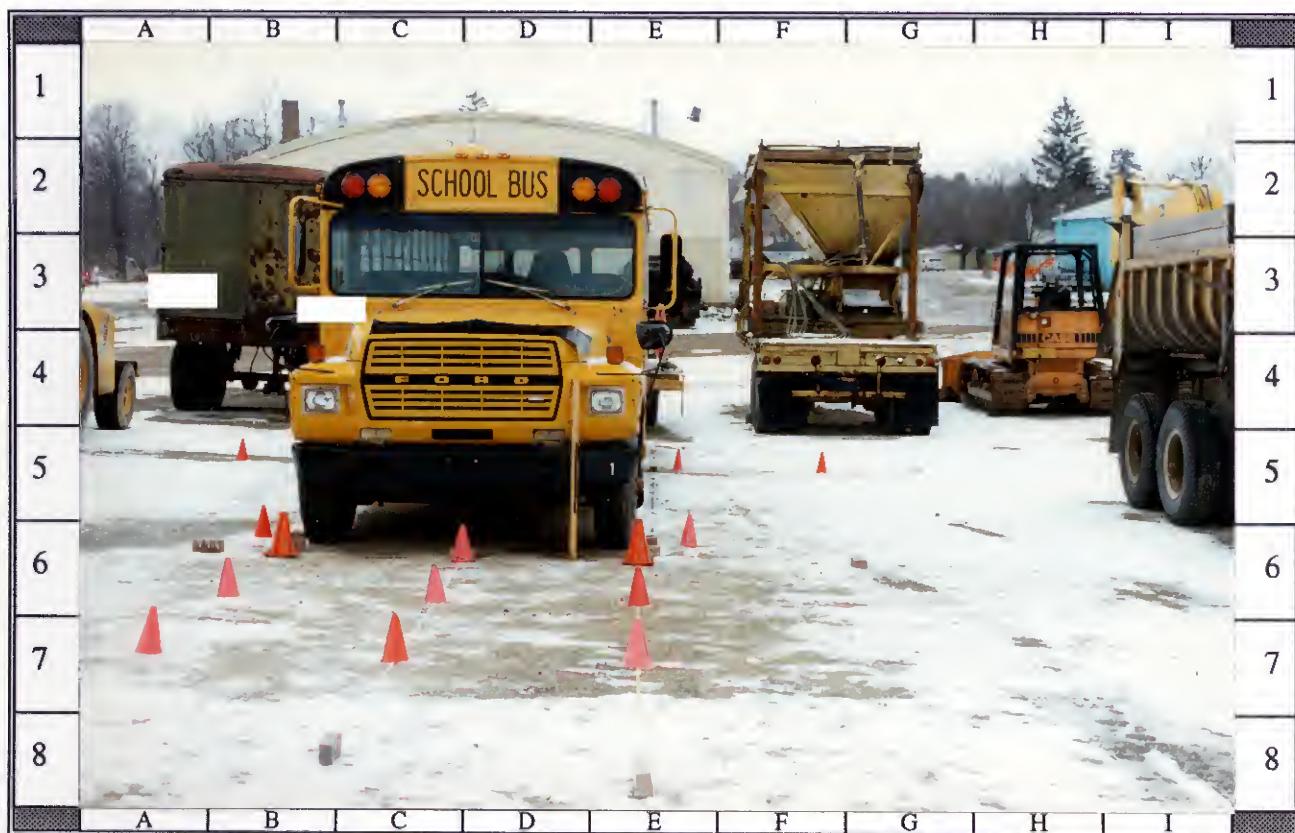
# 09: Case Vehicle viewed in alignment with cones A, D, and G and longitudinal vertical plane tangent to left bumper; NOTE: measuring stick marks impact area

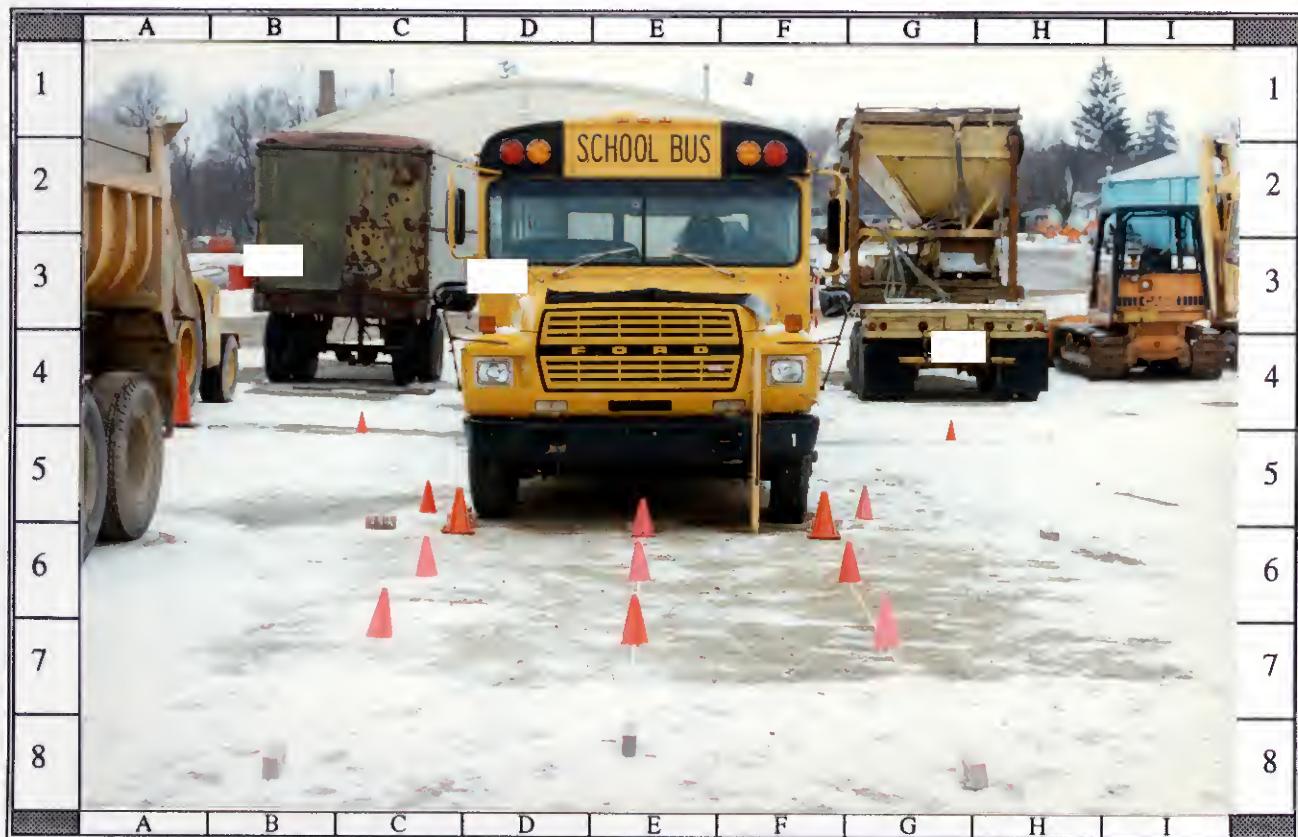
# 10: Case Vehicle viewed in alignment with cones B, E, and H and longitudinal vertical plane through center of bus; NOTE: measuring stick marks impact area

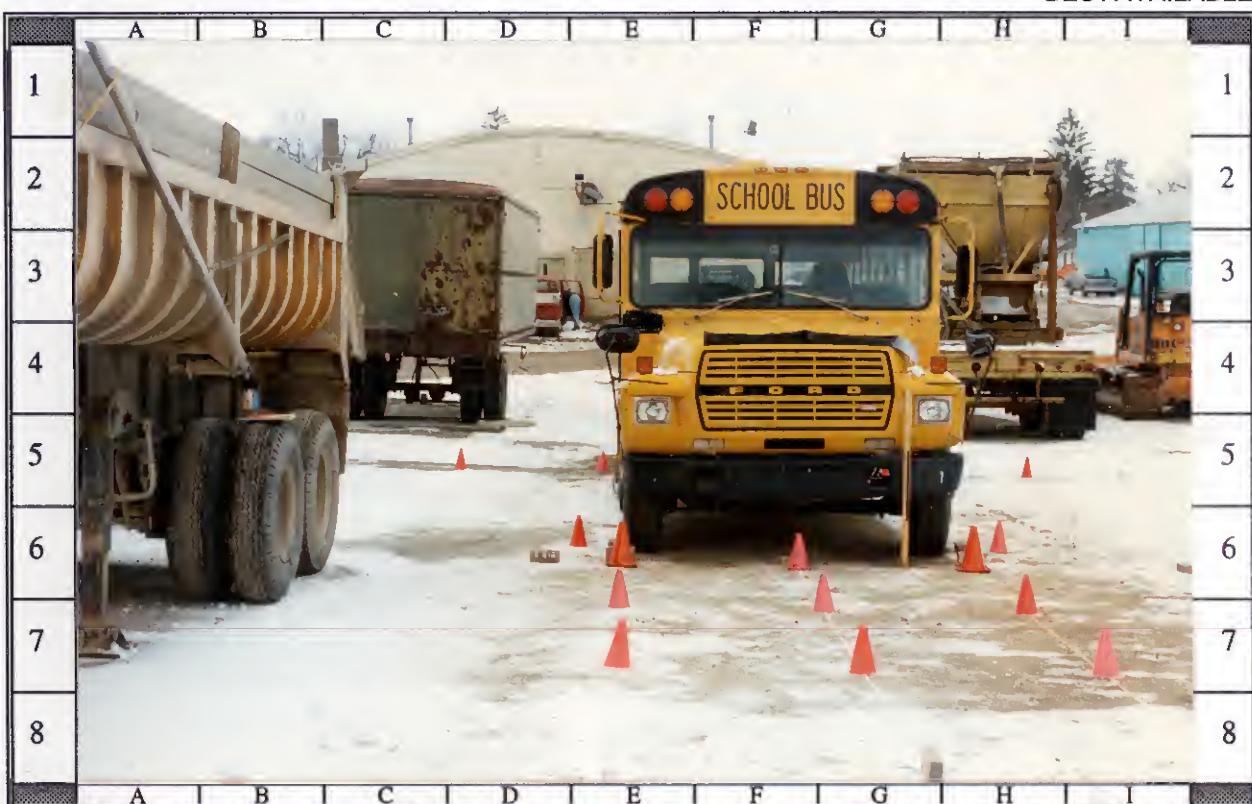
# 11: Case Vehicle viewed in alignment with cones C, F, and I and longitudinal vertical plane tangent to right bumper; NOTE: bricks secure tape measures

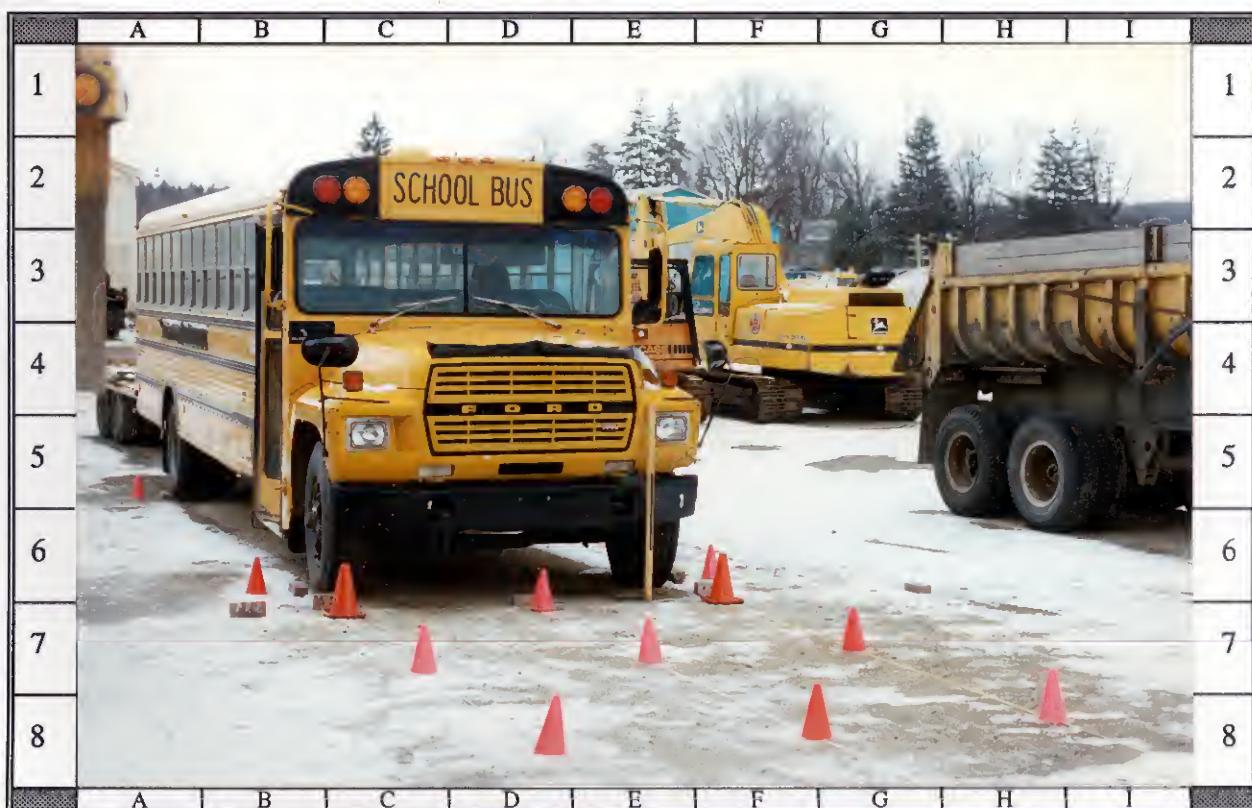
# 12: Case Vehicle and forward test cones A-I viewed from approximately 30 degrees right of front; NOTE: outside, convex, rearview mirrors mounted bilaterally

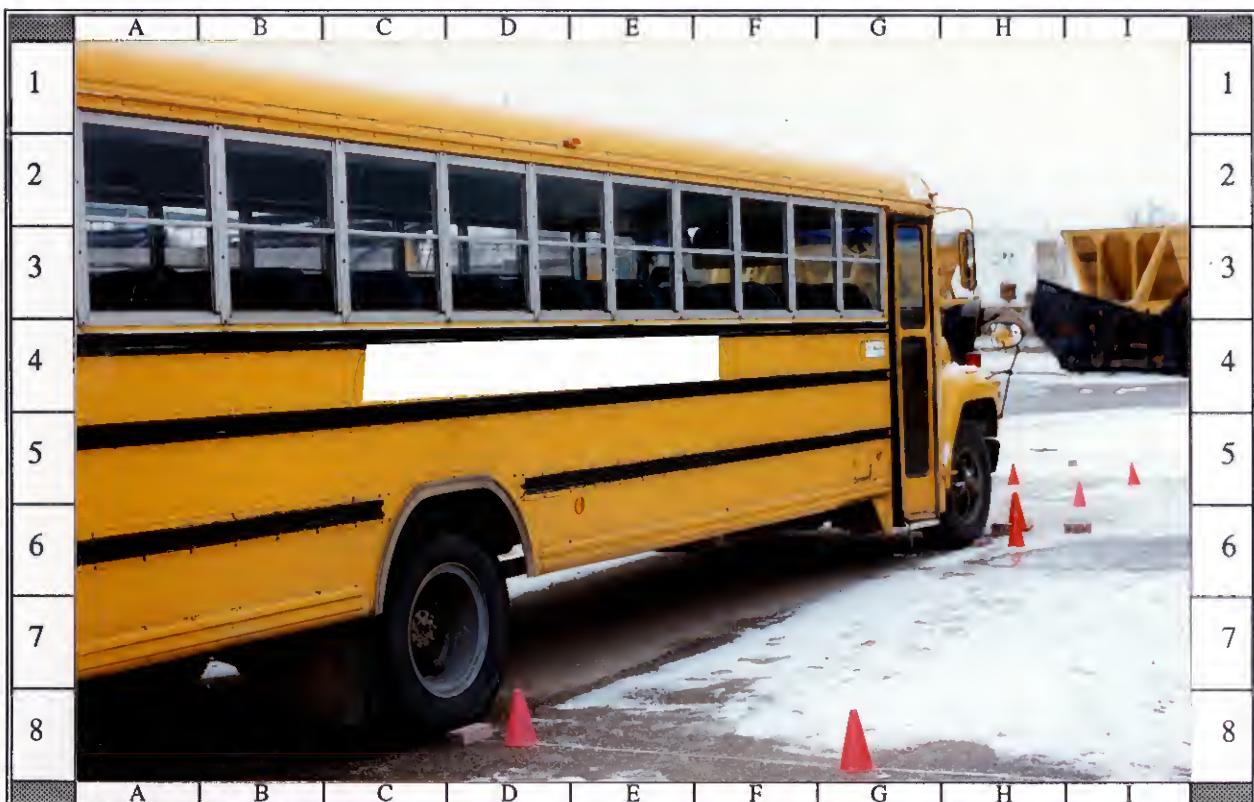
# 15: Case Vehicle and test cones B, C, F, I, K, N, and O viewed from approximately 45 degrees right of back; NOTE: cones N and O are aligned with rear axle

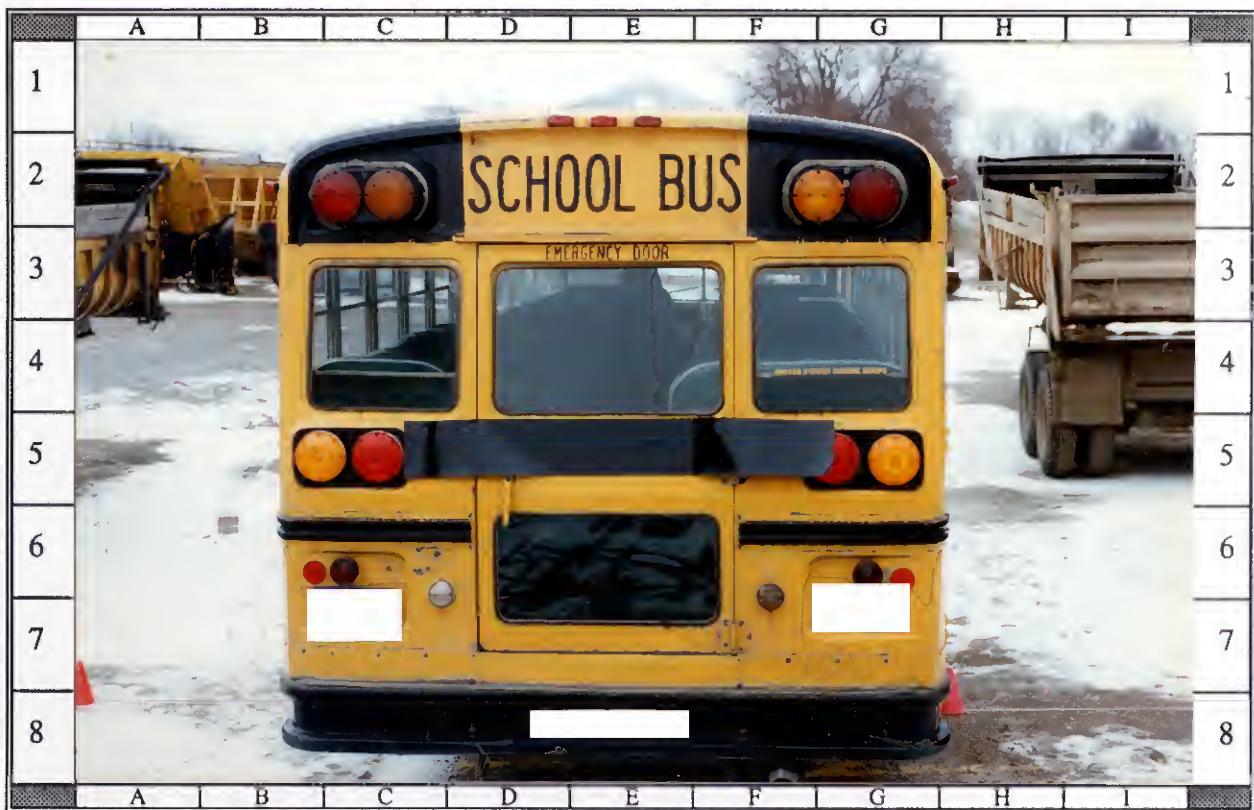
# 16: Case Vehicle's back and partially visible test cones L (left) and N (right); NOTE: seating visible through glazing

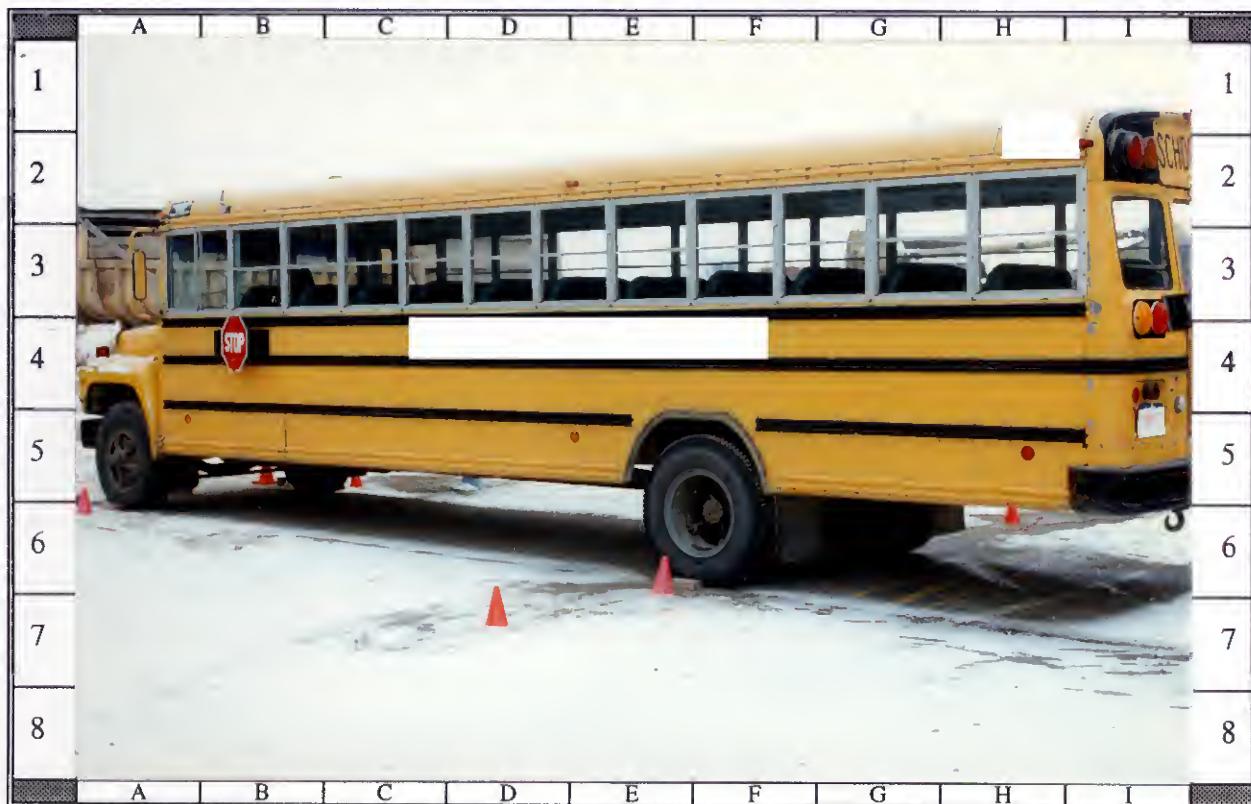
# 17: Case Vehicle and test cones J (left front), I & K (right front), L & M (left rear), and O (right rear) viewed from approximately 60 degrees left of back

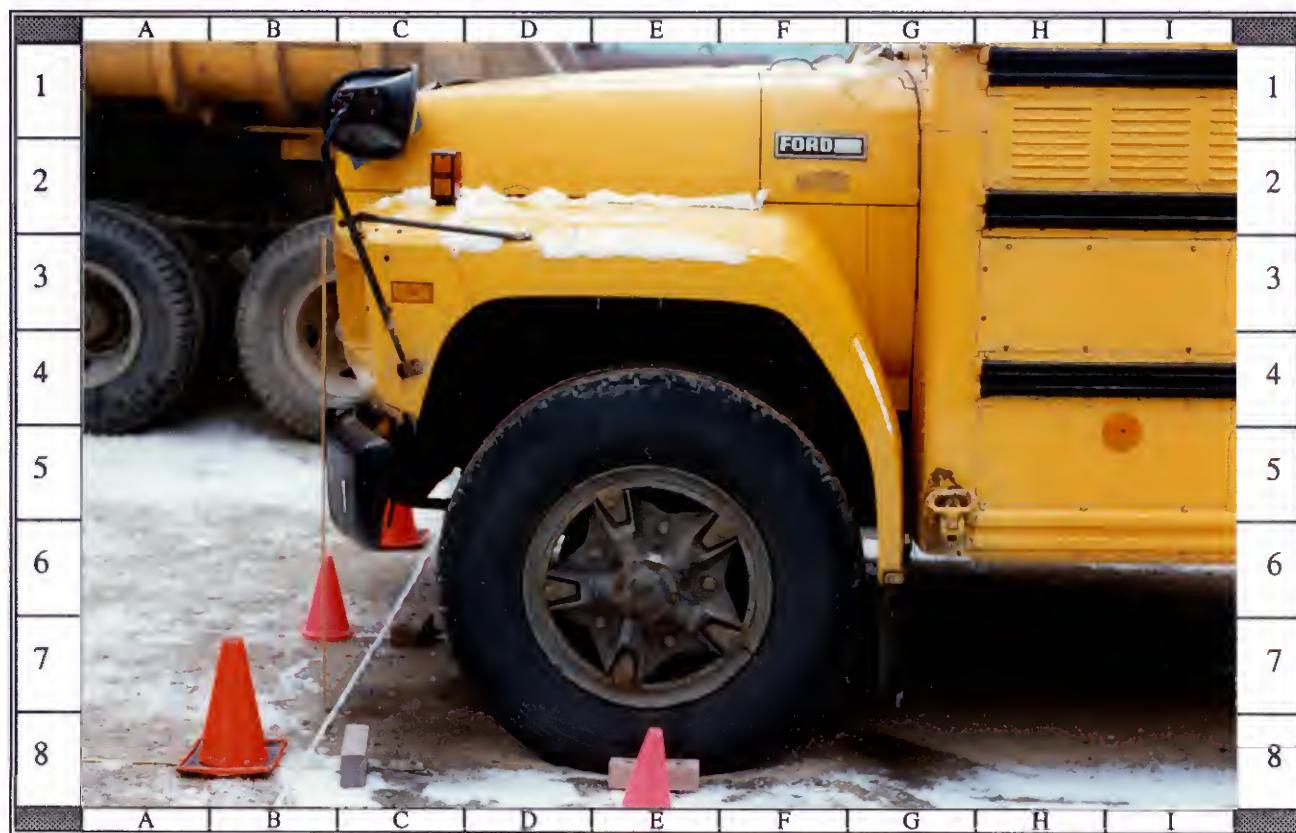
# 19: Case Vehicle's left front wheel and test cone J aligned with axle; NOTE: bracket locations for single left, outside, convex, rearview mirror

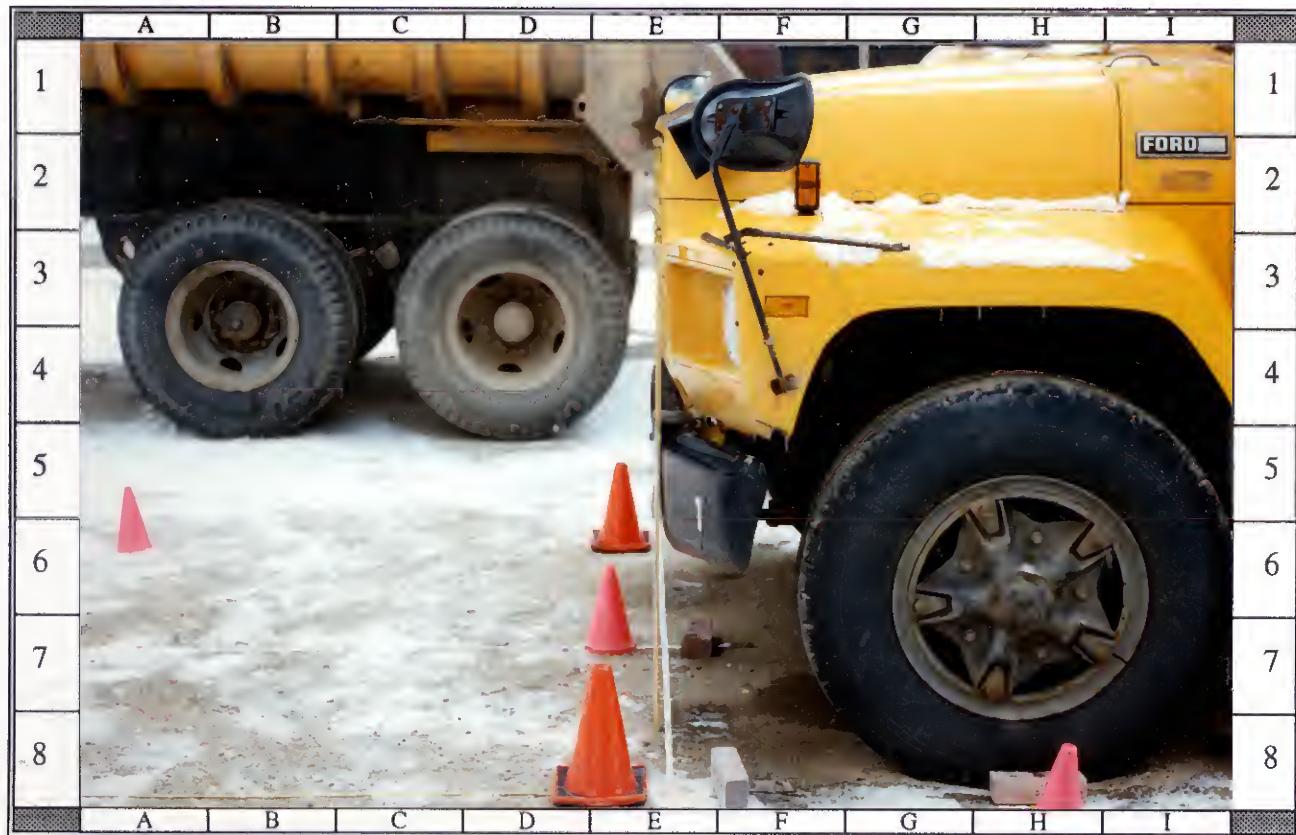
# 20: Case Vehicle viewed in alignment with cones G, H, and I and transverse vertical plane tangent to front bumper; NOTE: right side mirror forward of one on left

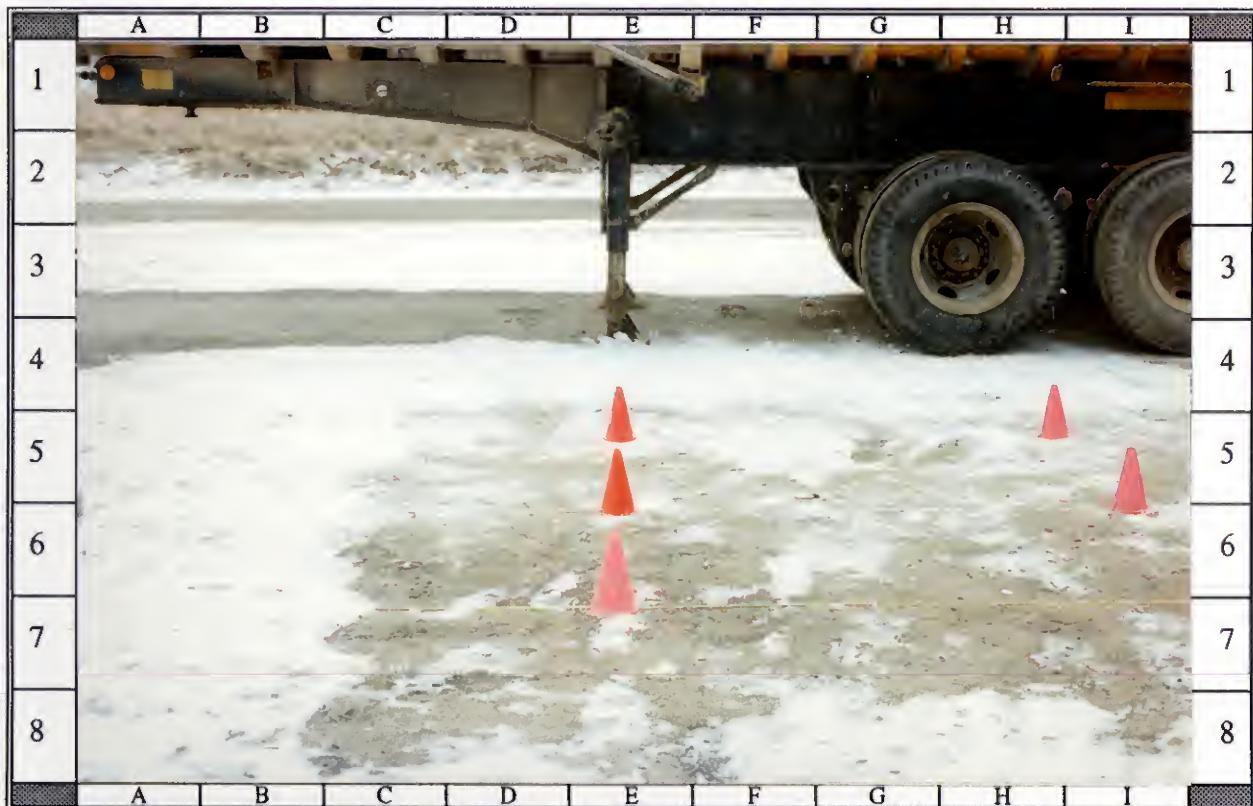
# 22: Case Vehicle's forward test cones A, B, and C viewed in alignment with transverse vertical plane 3.66 meters (12 feet) forward of front bumper

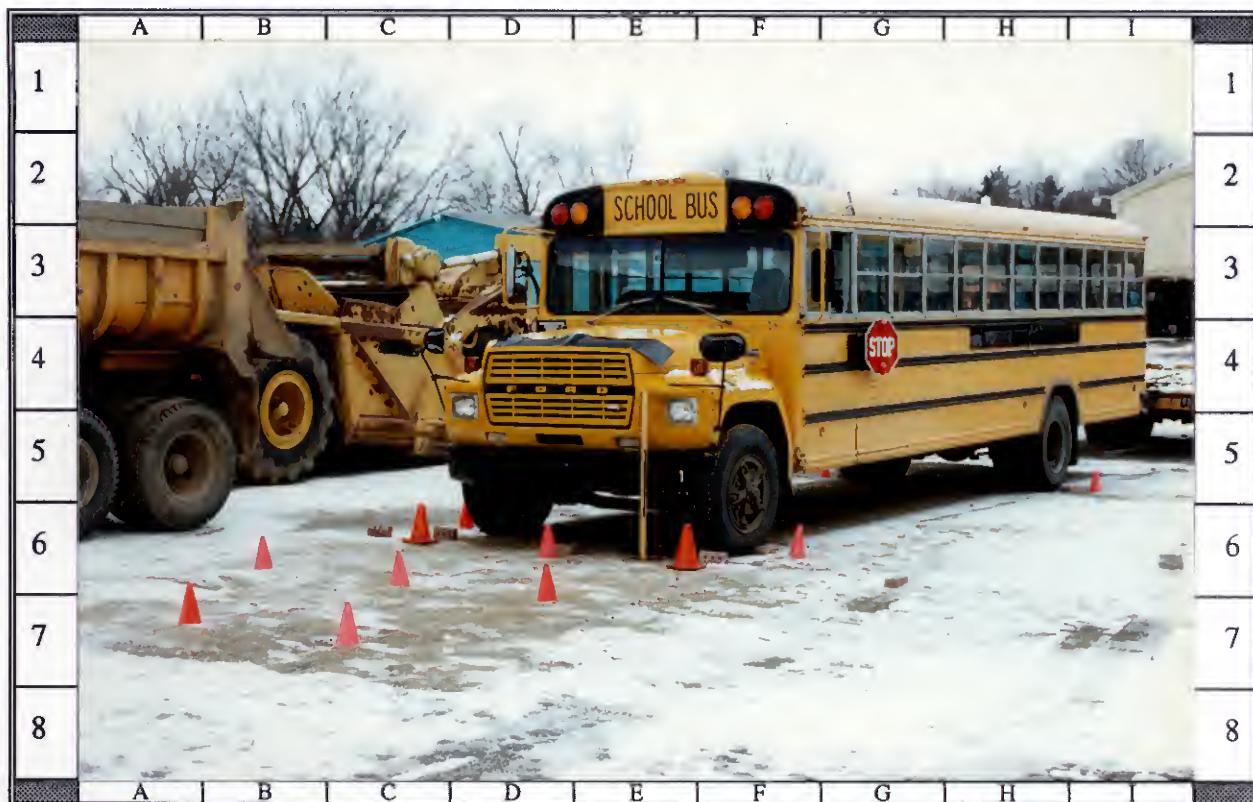
# 23: Case Vehicle and forward test cones A, B, and D-I viewed from approximately 30 degrees left of front; NOTE: measuring stick marks impact area

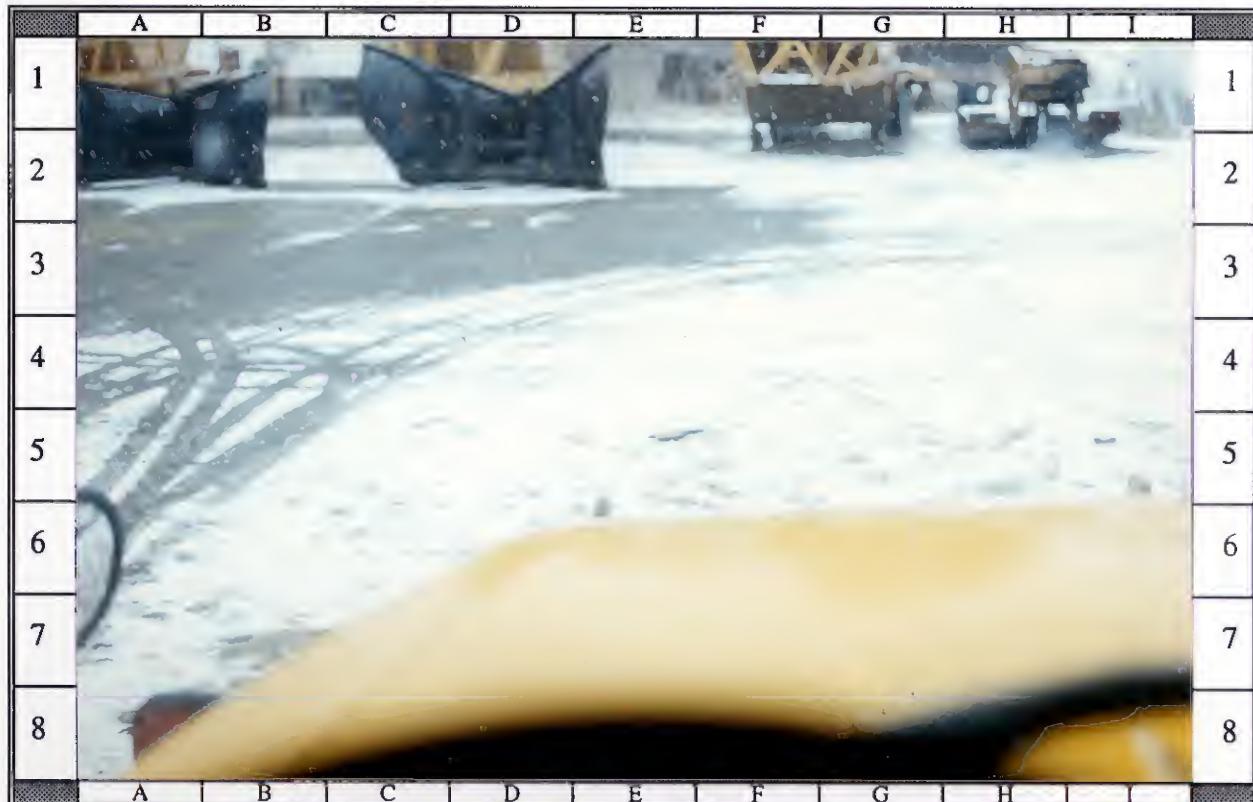
# 24: Case Vehicle driver's forward view through windshield of left third of bus's front; NOTE: bricks (cells E5 and I5) are ~ 6.1 m (20 ft) forward of bumper

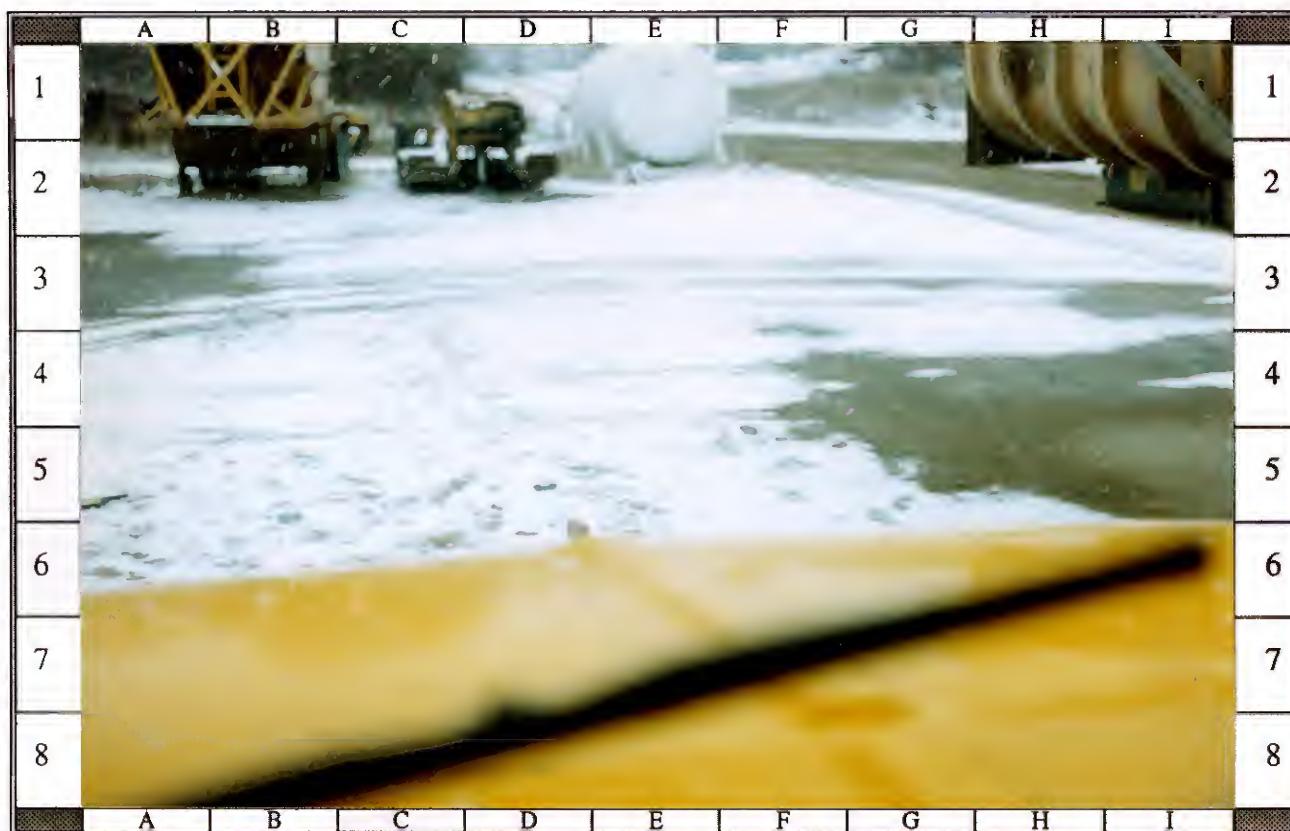
# 25: Case Vehicle driver's forward view through windshield of center third of bus's front; NOTE: brick (cell D6) is ~ 6.1 meters (20 feet) forward of bumper

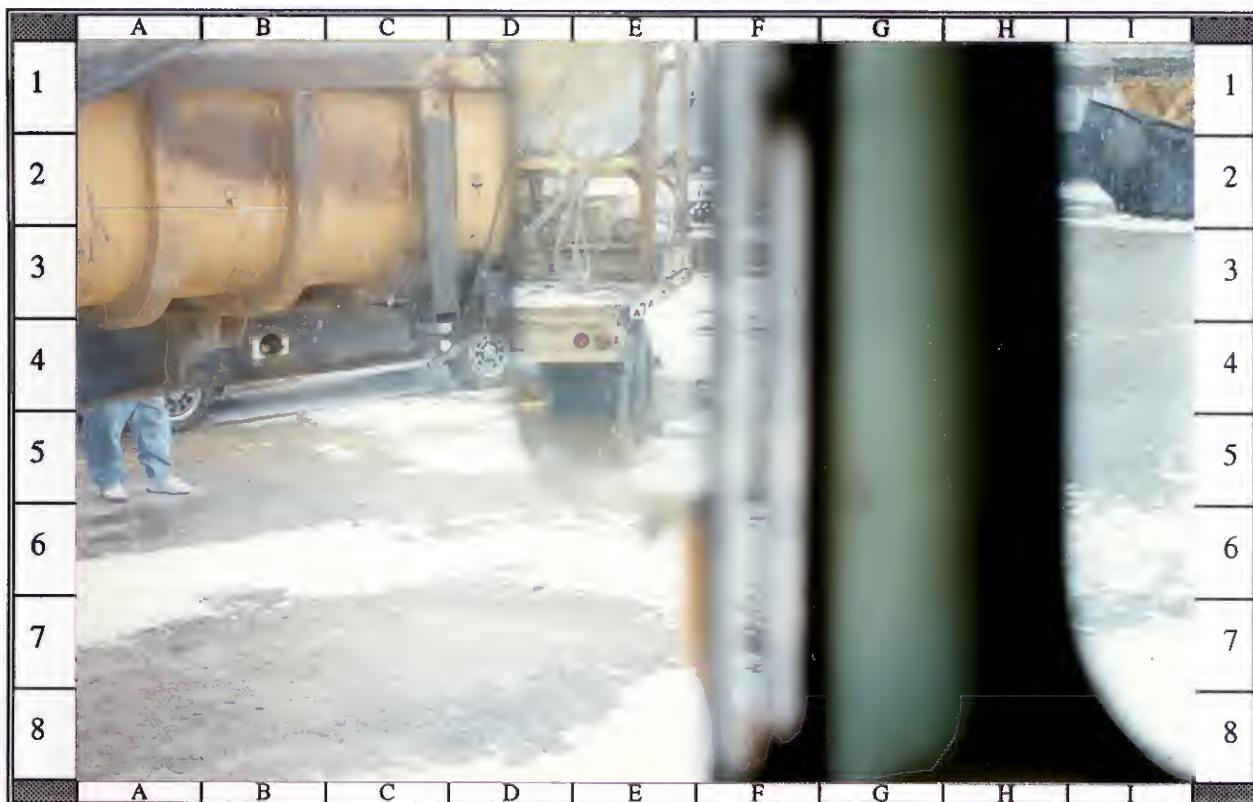
# 27: Normal view from Case Vehicle's driver seat through left, outside, unit magnification mirror; NOTE: test cones L and M are not visible
